**SITE CLASSIFICATION
LOT 633 GREENWAY STREET
LLOYD NSW 2650**

September 2016

Site Classification: M-D - Moderately reactive clay or silt sites (Deep Drying)

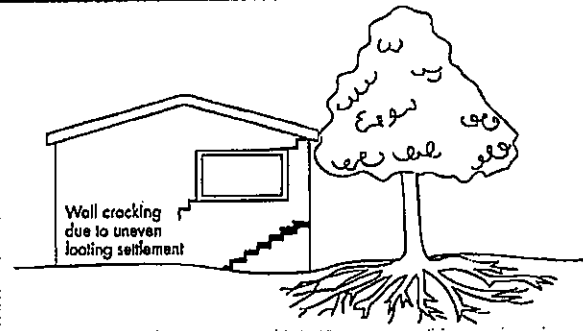
Trees can cause shrinkage and damage

external footings. The doming is accentuated and cracking reduces or disappears where it occurred because of dishing, but other cracks open up. The roof lines may become convex.

Movement caused by tree roots

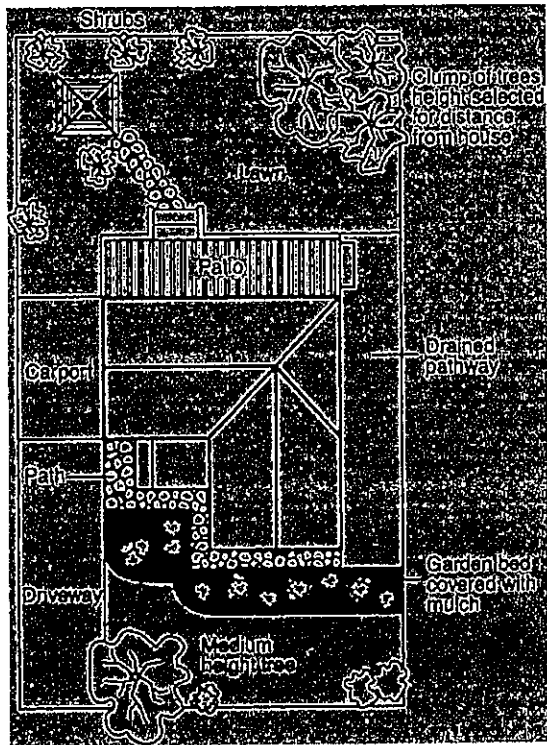
Gardens for a reactive site

extend outwards a minimum of 900 mm (more in highly reactive soil) and should have a minimum fall away from the building of 1:60. The finished paving should be no less than 100 mm below brick vent bases.

It is prudent to relocate drainage pipes away from this paving, if possible, to avoid complications from future leakage. If this is not practical, earthenware pipes should be replaced by PVC and backfilling should be of the same soil type as the surrounding soil and compacted to the same density.
